DAM A-21

LAFAYETTE COUNTY, MISSOURI

MO 10144

# PHASE I INSPECTION REPORT NATIONAL DAM SAFETY PROGRAM

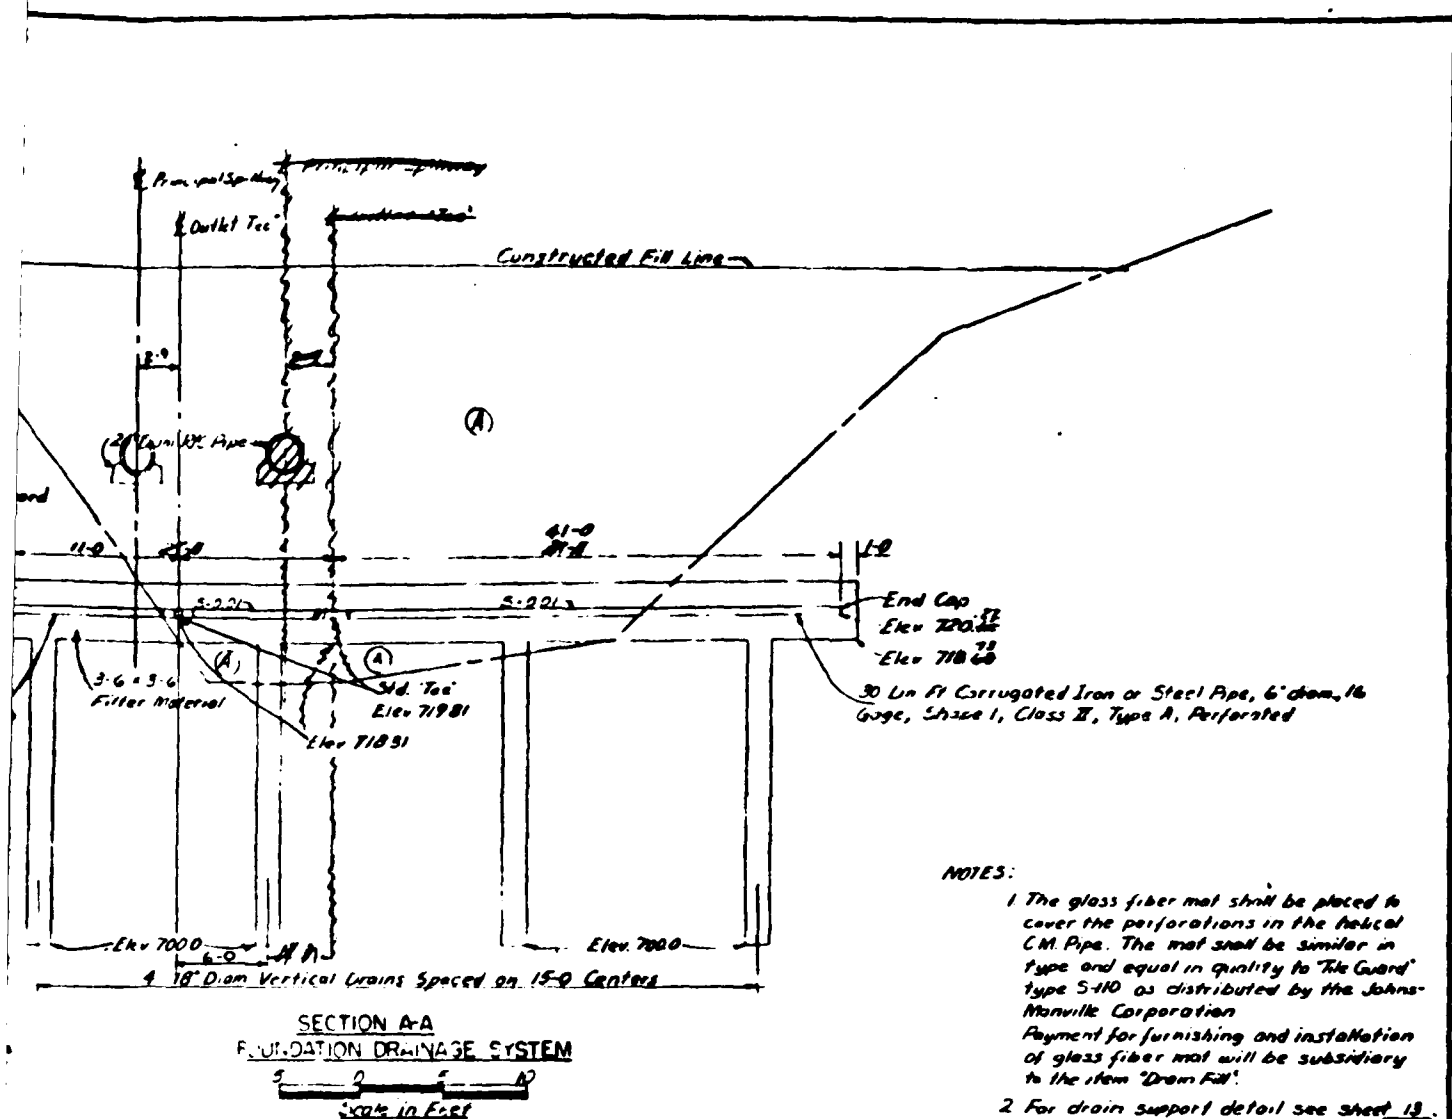
**SHEET 6 APPENDIX A**

Slope stability analyses were performed, but seepage analyses comparable to the Recommended Guidelines were not available. The foundation drainage system shown on Sheet 6 of Appendix A would indicate that a seepage analysis has been performed. The owner should either locate these analyses or have them performed by an engineer experienced in the design of dams.

Along the last portion of the primary spillway outlet pipe, there is a 6 in. diameter corrugated iron pipe (Class II, Type A), which is the outlet of the foundation drainage system for the embankment. The pipe has a length of 80 ft and a slope of 0.010. It is shown on Sheets 5 and 6 of Appendix A.
